U1 HP Turbine Upgrade Acceptance Test Results Summary

INTERMOUNTAIN POWER SERVICE CORPORATION

**UNIT 1 HP TURBINE
FACTORY INSPECTION
REPORT**

Dated 12/10/02

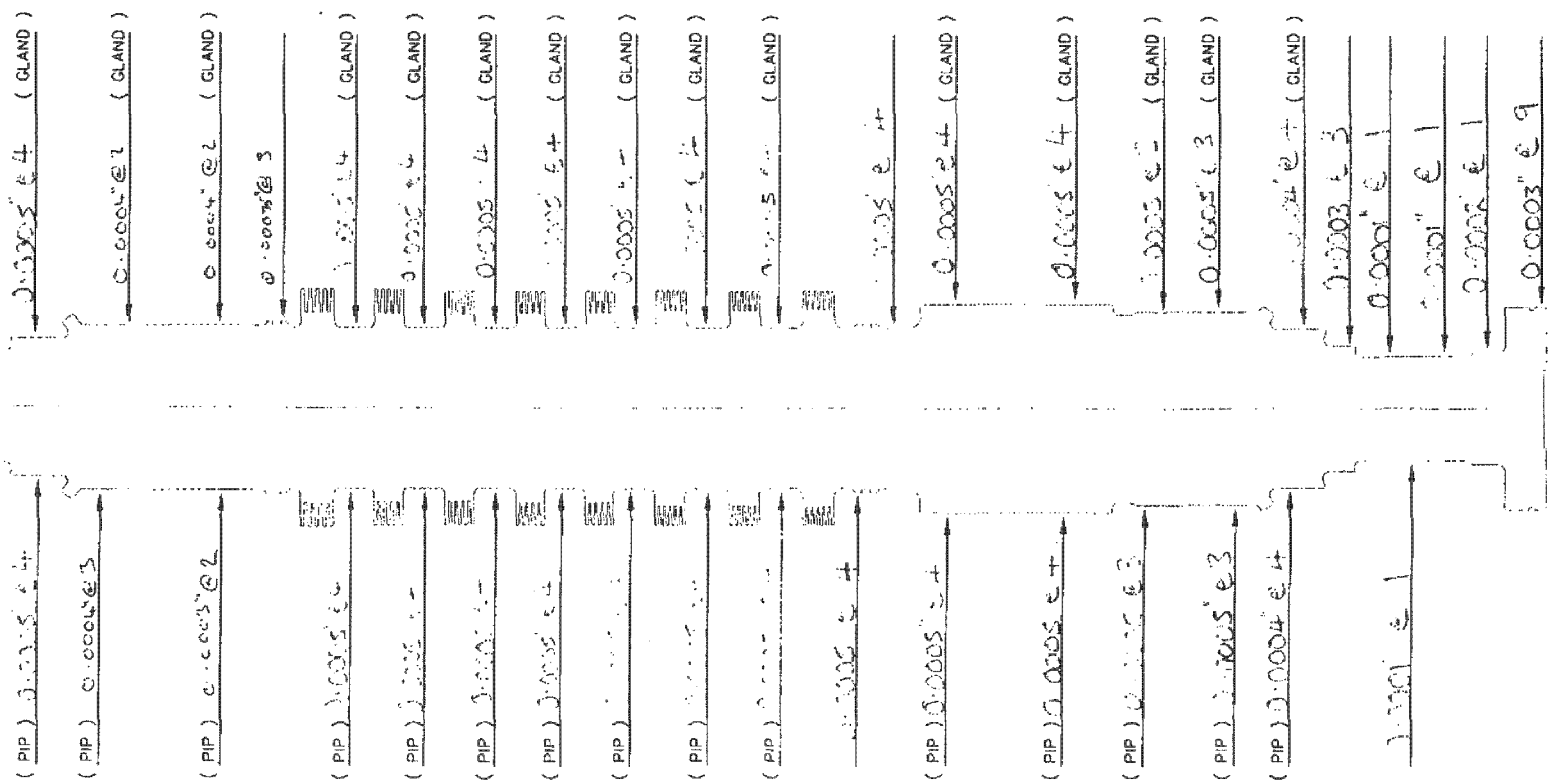
APPENDIX A - ROTOR RUN OUT

All rotor's run out dimensions are found to be better than the limits. Refer to the attached drawing.

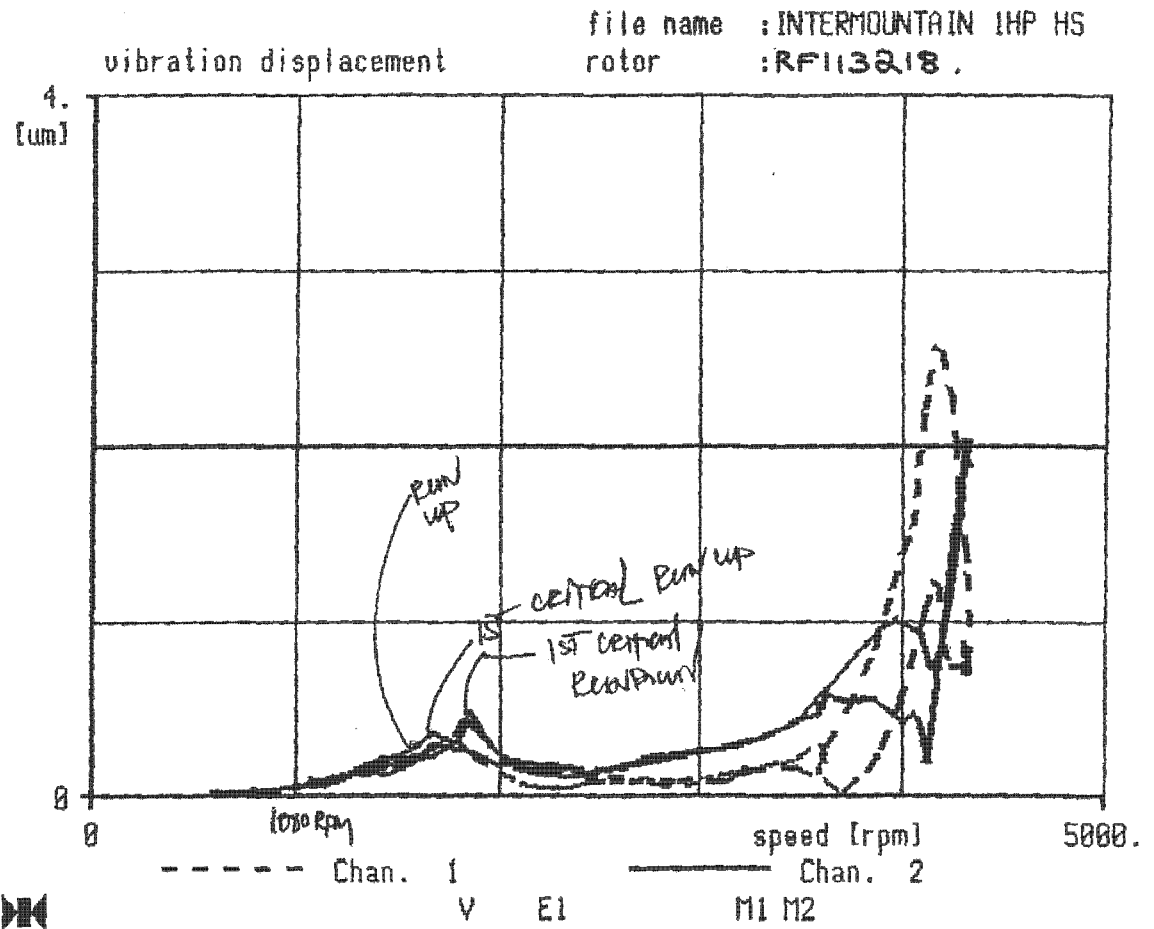
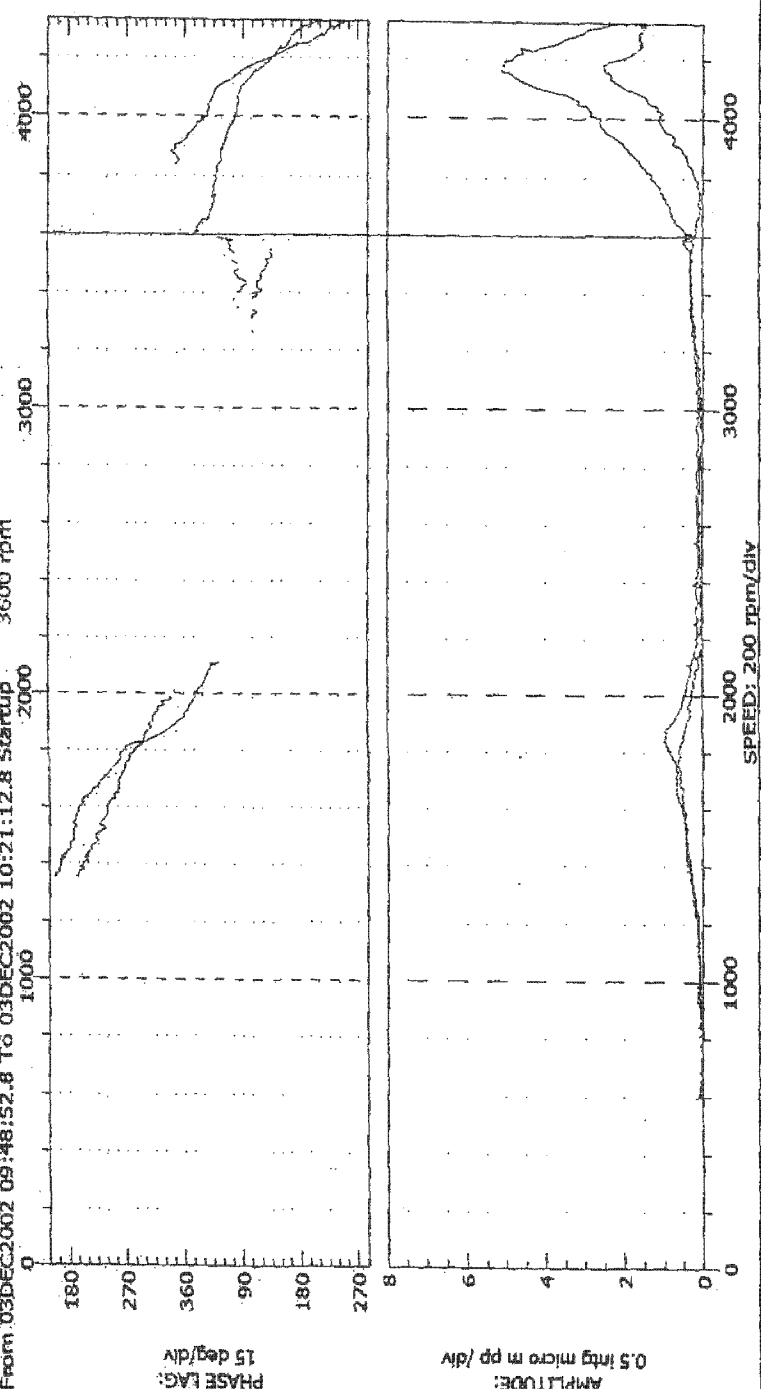
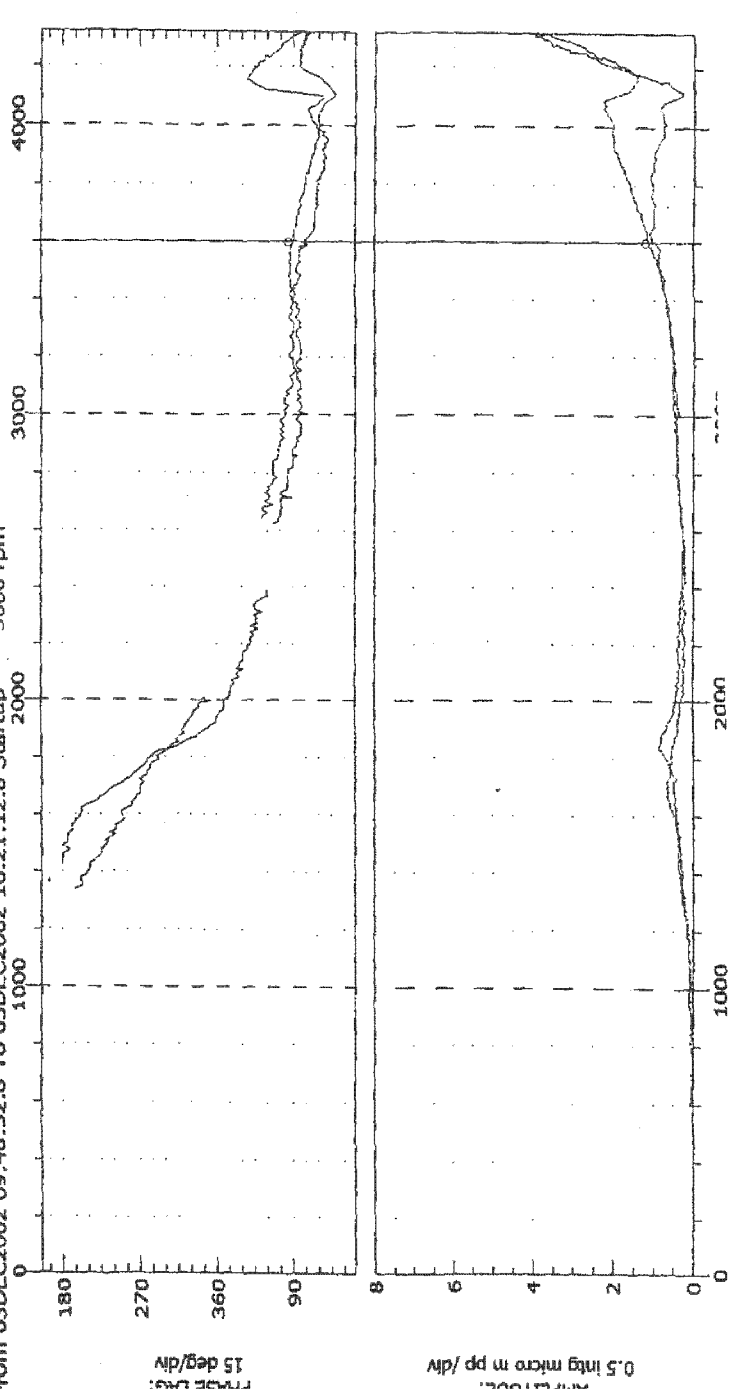
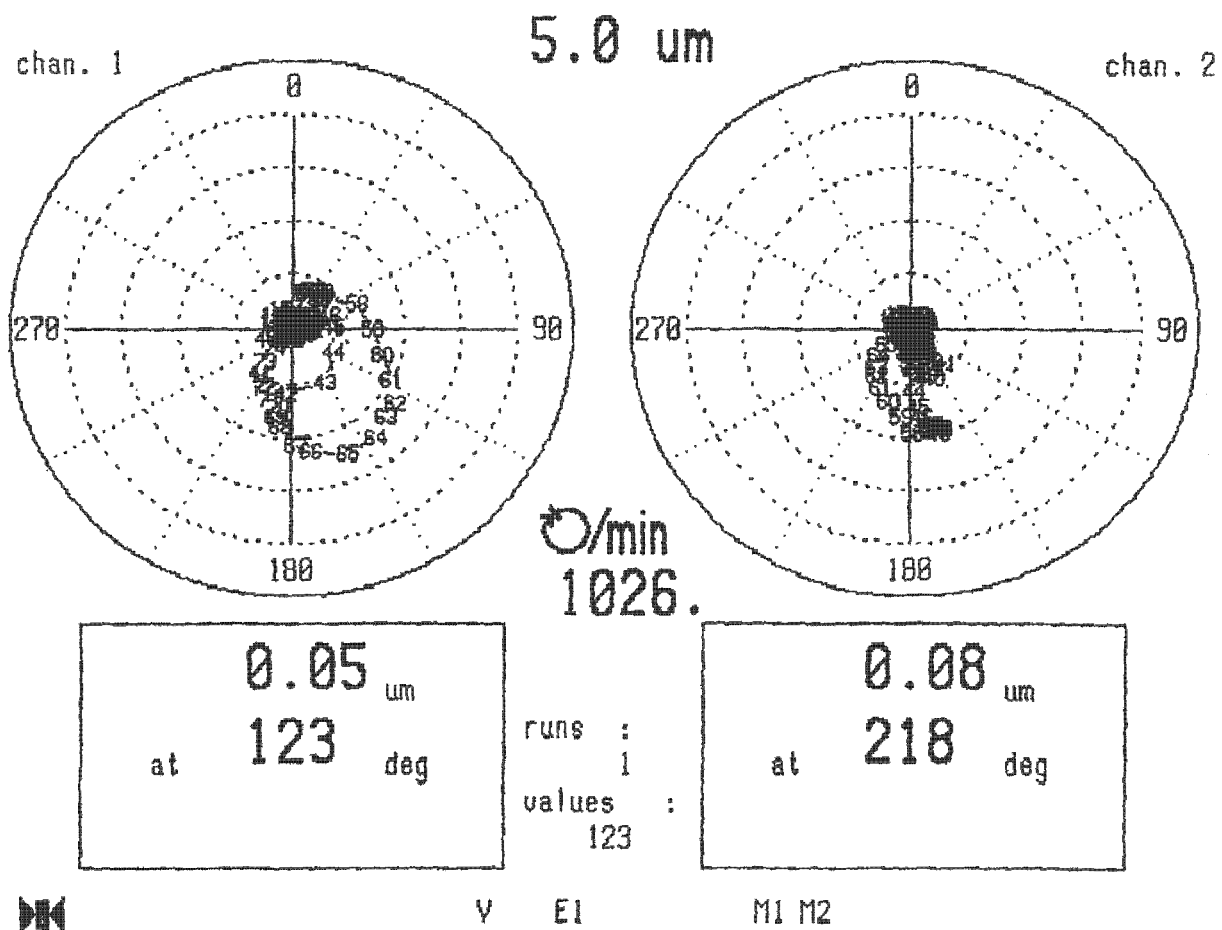
APPENDIX B - HIGH SPEED BALANCE

The primary work scope consisted of a spot check and visual inspection of the fit, clearances, coupling, bearing journal, rotor run out, control rotor machining, and dynamic over speed balancing. The overall HP rotor high speed's peak-to-peak vibration was extremely good with the maximum displacement at the 2nd critical speed (4170 rpm) of 0.0002". (Refer to Appendix B.)

The high speed dynamic balancing was completed twice, with five minutes over-speed intervals, on the Unit 1 HP completed bladed rotor. The rotor went through the 1st critical (1930 rpm) and 2nd critical (4170 rpm) speeds with exceptionally low vibration. The maximum peak-to-peak displacement vibration is 3.6 micro inches (0.0002"), better than that of the U2's HP (13.6 micro inches.) The Alstom maximum acceptable is 16.0 micro inches and GE maximum acceptable is 25.0 micro inches. Refer to the Table 1 and attached graphs.

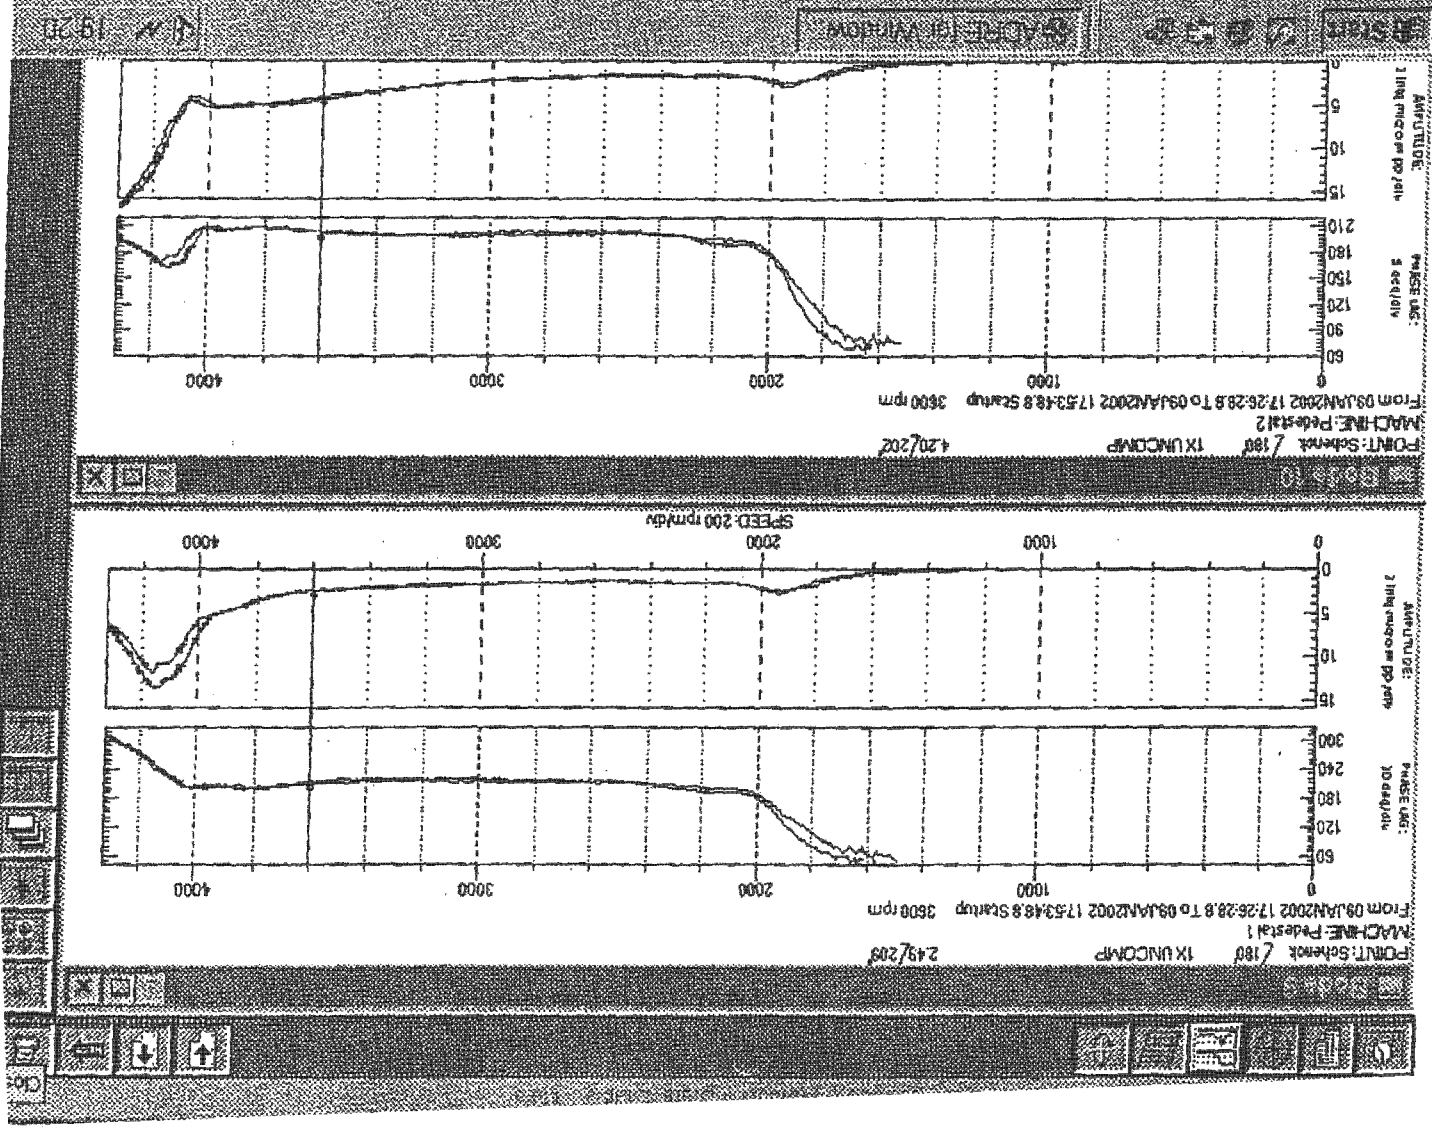
R.P.M.	Front Ped um	Rear Ped um	um
1940	2.78	2.78	16
3600	2.49	4.2	8
3960	5.34	5.46	16
4160	13.6	9.7	16
4320	6.78	17.1	16
	HP REAR	HP FRONT

ROTOR OVERSPEED TO 4320 RPM (20% OVERSPEED) FOR 5 MINUTES.

* PERFORMANCE ACCEPTED BY DESIGN DEPARTMENT.
